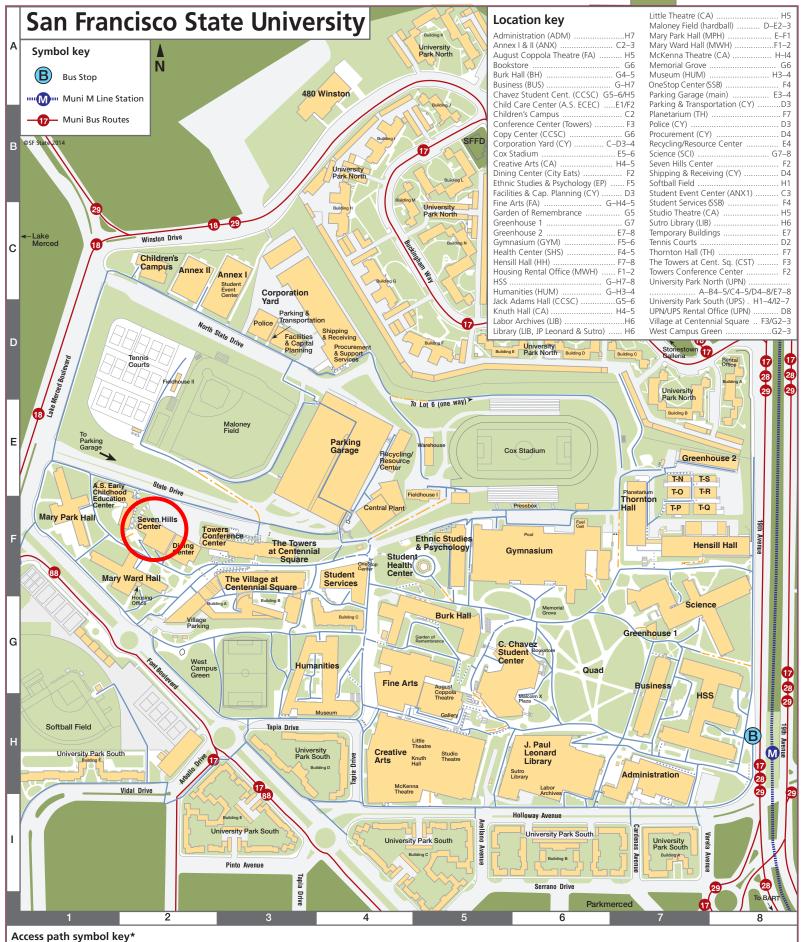
Accessible Route—This path generally conforms to accessibility standards.

Areas that may be a travel hazard (where the slope exceeds the standard maximum ramp slope [8.3%], or the cross-slope is significant [exceeds 4%]).

Ramp (5%–8.3%)—Complying ramp along the accessible route.

Partially Accessible Route—This path generally conforms to accessibility standards, but there may be excessive cross-slope (over 2%) or other irregularities in a portion of the path, often along the path edge. There is usually a 48" wide complying path along these routes, though it may not be a straight or direct line.

Lighter shade indicates path continues underneath overhang.

Note: The map and information on pathways are limited by the scale. The accessible route should be clear to a person at a location, while the dashed line is intended to indicate where keener observation may be necessary to locate the accessible route. Pathways are generally asphalt and subject to weathering, erosion, uplifting, and other changes that may create navigational issues. SFSU is committed to maintaining the accessible route. Please report any irregularities to Disability Programs and Resource Center, 415-338-2472 (voice, TTY).
